DETECTIVE

STORY: Why did a hydrostatic pressing vessel fail?

RICHARD A. TERSELC
Lewis Research Center,
National Aeronautics and Space
Administration, Cleveland, Ohio

Repr. from N 64 13198 *
Safety Engineering and Safety Maintenance, Nov. 1963
CODE NONE
(NASA RP-92) 4p

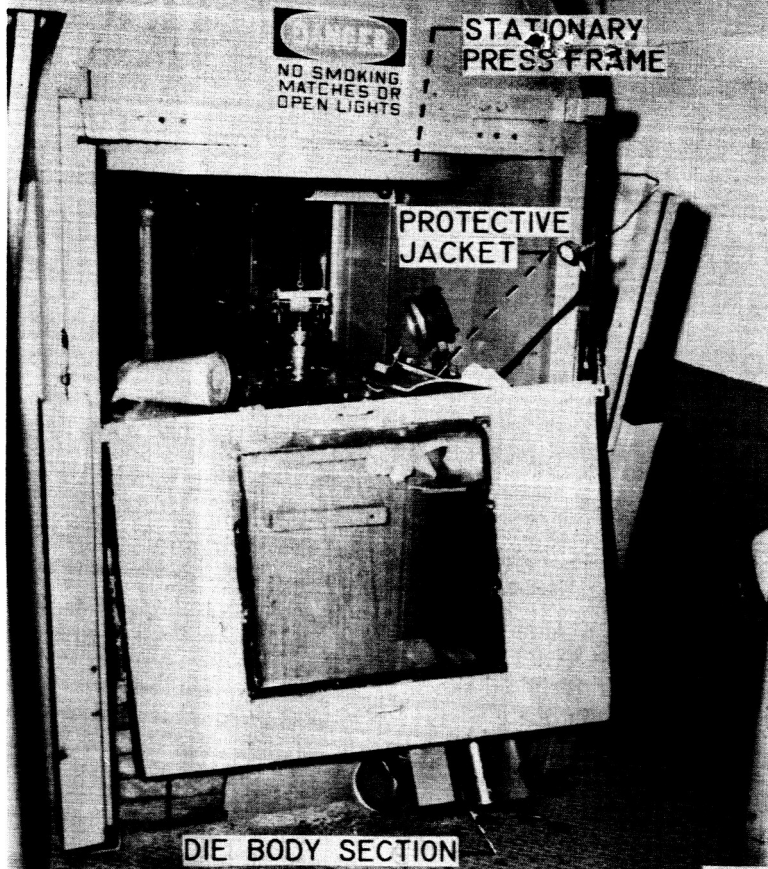
Fig. 2. A view of the hydrostatic pressing facility taken after die failure. Broken die section appears in lower r.h. corner.

After the completion of approximately 140 operating cycles, a run was inadvertently made at 60,000 psi. At this pressure, the die body unexpectedly failed and fractured into five pieces. Fortunately, no personnel injuries occurred, and the five fractured metal pieces were all contained within the press housing and associated safety enclosure. Property damage was also confined to this immediate area. Figure 2 is a photo of the pressing facility as it appeared following the failure. Figure 3 shows the three main sections and the two shrapnel-like fragments.

A mild steel jacket had been placed around the vessel to retard the motion of any fragments that might be created during a possible die body failure. When the vessel ruptured, this jacket was opened along its bolted vertical seams. The bolts constraining the two halves of the jacket failed in tension and were projected against the cast steel walls of the press enclosure. The twisted condition of this jacket indicates that it effectively absorbed much of the blast energy.

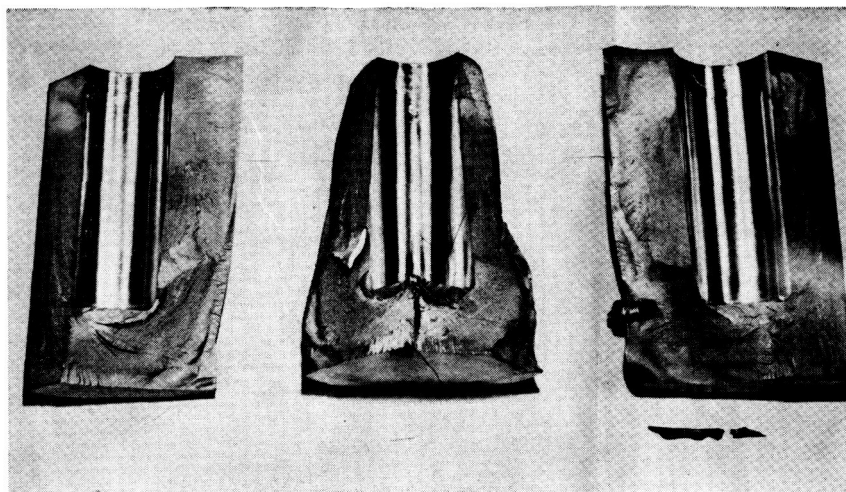
Fig. 3. The three main sections and two shrapnel-like fragments of the failed die body as they appeared following failure.

The original die set was placed back in service after a successful proof test and has accumulated well over 100 additional pressing cycles without failure. The intensifier is also used as a pressure source for an auxiliary pressure vessel. A pressure tap (using a standard pipe thread for sealing), has been used to accomplish this task. When the vessel that failed was originally placed into service, difficulty was encountered in maintaining a leak-tight seal. In order to remedy this difficulty, the tap connection threads were coated with a low-temperature soft solder and were wrapped with Teflon tape before installation in the die body. Failure progressed along the centerline of this connection yet the plug remained in place (Fig. 3). This method seems to be an effective means of making a high-pressure seal.

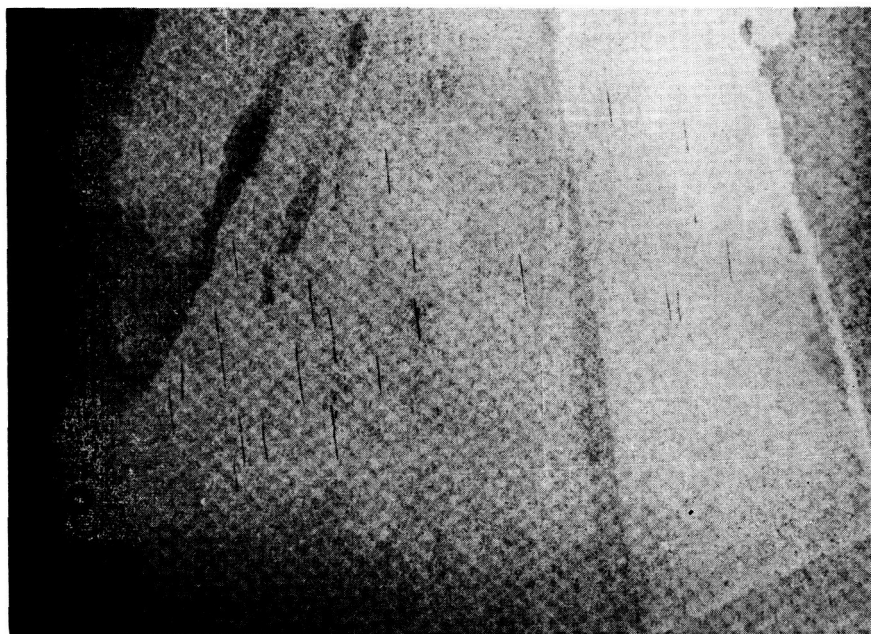
Fig. 4. A full size view of the macroetch of the body bore. Dark, vertical lines in center of photo are grinding checks.

"The readily noted difference in macro appearance between the top and bottom of the section can be attributed to the way in which

the failure propagated. The fine grain structure seen in the upper portion of the die body fragment indicates the early progress of the failure. The failure origins lie at the apex of the smooth flowing, radiating lines. The coarse structure near the bottom of the fragment represents an area where the material was torn apart as the failure progressed downward. Based on these observations, it is concluded that the initiation of the failure can probably be attributed to grinding checks."

Since these checks are the most likely cause for the initiation of failure, it may be of value to discuss them. The intensifier die body and piston were surface-ground in order to produce a fine finish and an accurate diametral clearance of 0.001 to 0.003 inch. Since the parts were extremely hard, no other surface finishing process was applicable. During such a grinding operation, care must be taken to prevent overheating the work surface. Overheating can result from a shortage of coolant at the work surface or from attempts at removing excessive amounts of stock in a single pass. Evidence of overheating was demonstrated by the local areas of tempering previously mentioned. Rapid overheating and cooling of small areas on a hardened surface can also result in the development of microscopic cracks that occur parallel to the rotational axis of the grinding wheel. Although the cracks are microscopic at the time of their creation, they act as definite stress risers. As the pressure in the die body was cycled, the cracks grew in size as the result of a fatigue process. As the cracks grew, it is reasonable to assume that their effect as stress risers increased. Thus, localized areas probably existed where the actual stress level was much higher than would normally occur for a given internal pressure. Eventually a crack (or cracks) grew to a critical size and the yield strength of the material was exceeded. The hardened material allowed little plastic flow, and failure immediately proceeded.

Thus, if extremely high strength is necessary for an application such as this intensifier die body and a material requiring a high hardness is selected, *extreme care must be taken to prevent the production of stress risers such as grinding checks that can readily lead to premature and unexpected failure.* In order to avoid such difficulties, high-pressure design specialists limit the maximum hardness of such vessels to about Rockwell-C40.
